**DEBRIS/ICE/TPS ASSESSMENT and
INTEGRATED PHOTOGRAPHIC ANALYSIS
OF SHUTTLE MISSION STS-108**

Armando Oliu
Process Engineering/Mechanical System Division/ET-SRB Branch,
Kennedy Space Center, Florida

December 5, 2001

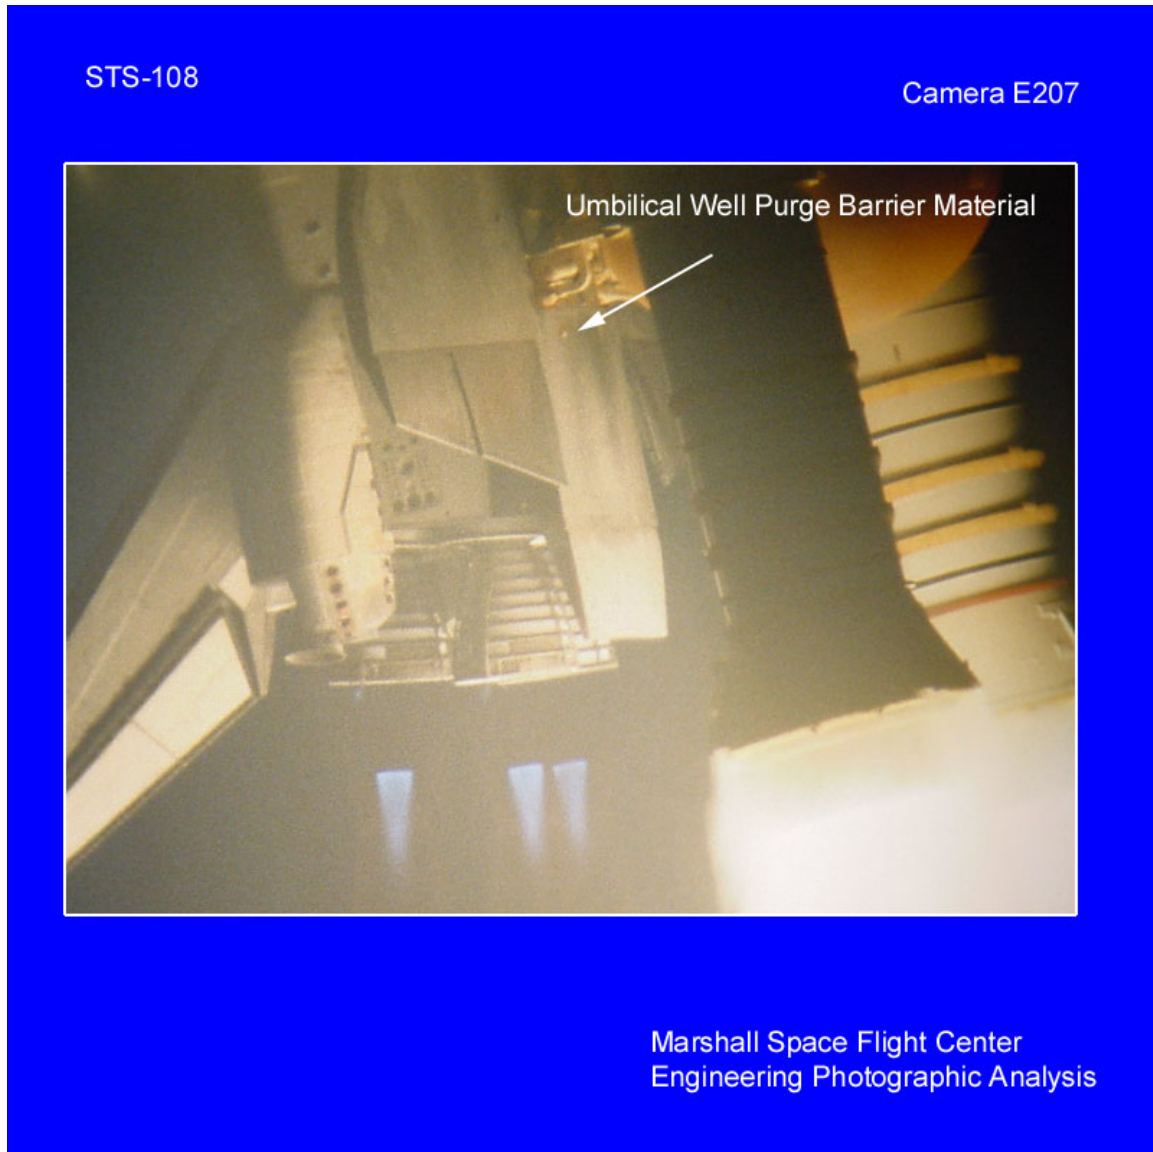
Figure 17. Film Camera E207: Umbilical Well Purge Barrier Debris

Debris was observed falling aft of the vehicle. This debris is thought to be umbilical well purge barrier material.

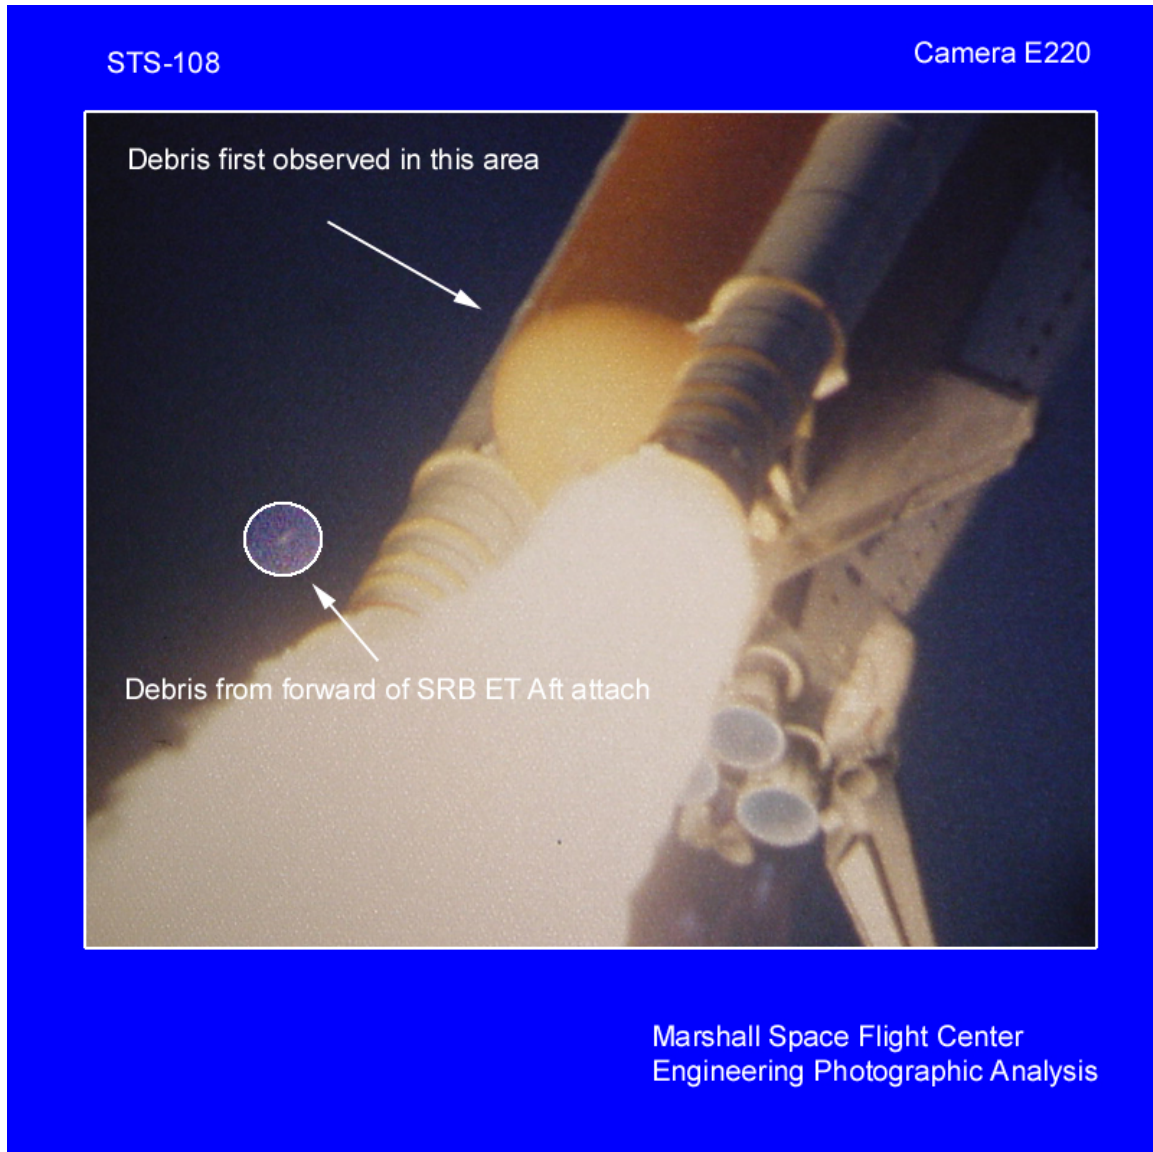
Figure 18. Film Camera E220: Debris Falling Aft

Debris was noted falling aft of the vehicle on the -Z side of the External Tank. The debris appeared to emanate from forward of the SRB-ET aft attach point.

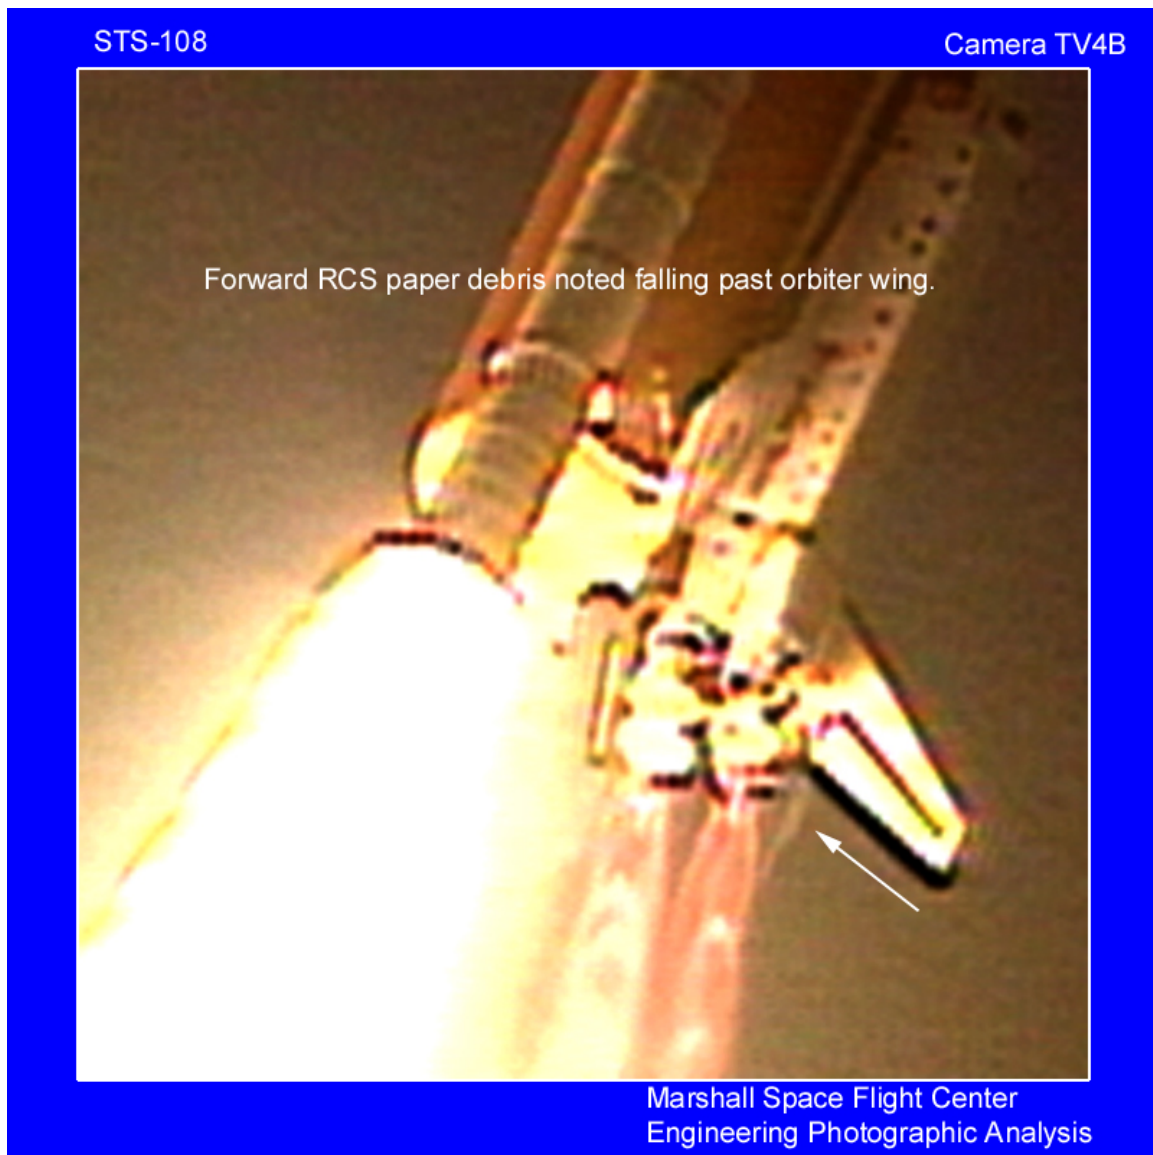
Figure 19. Video Camera TV4B: RCS Butcher Paper Debris

Debris flows aft of the vehicle. The debris is thought to be butcher paper from the forward RCS motors.

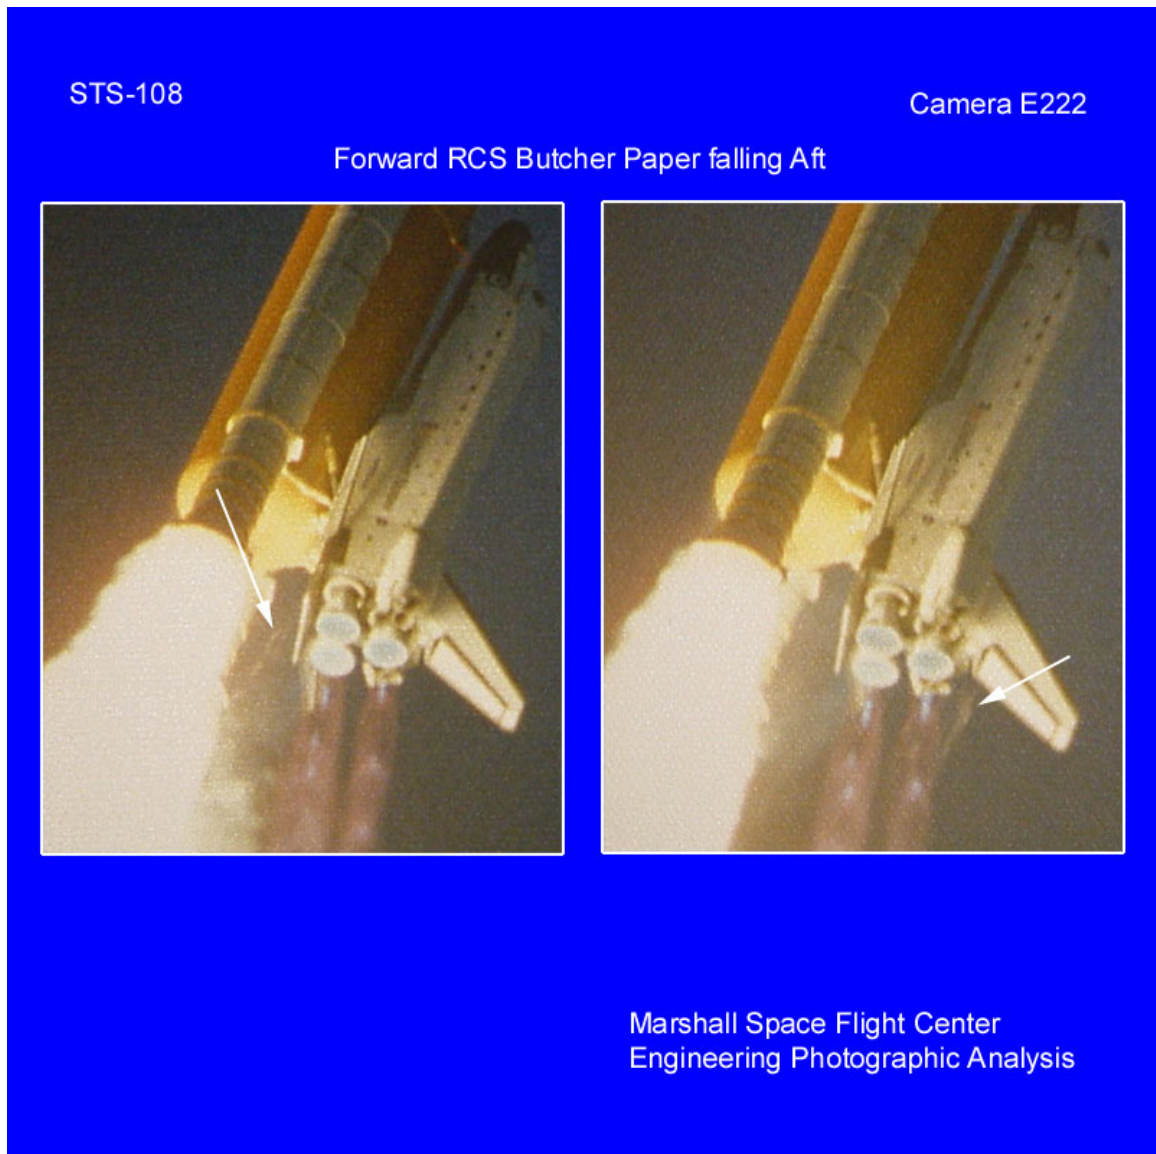
Figure 20. Film Camera E222: RCS Butcher Paper Debris

Debris was observed falling aft of the vehicle. This debris appears to be butcher paper from forward RCS motors.

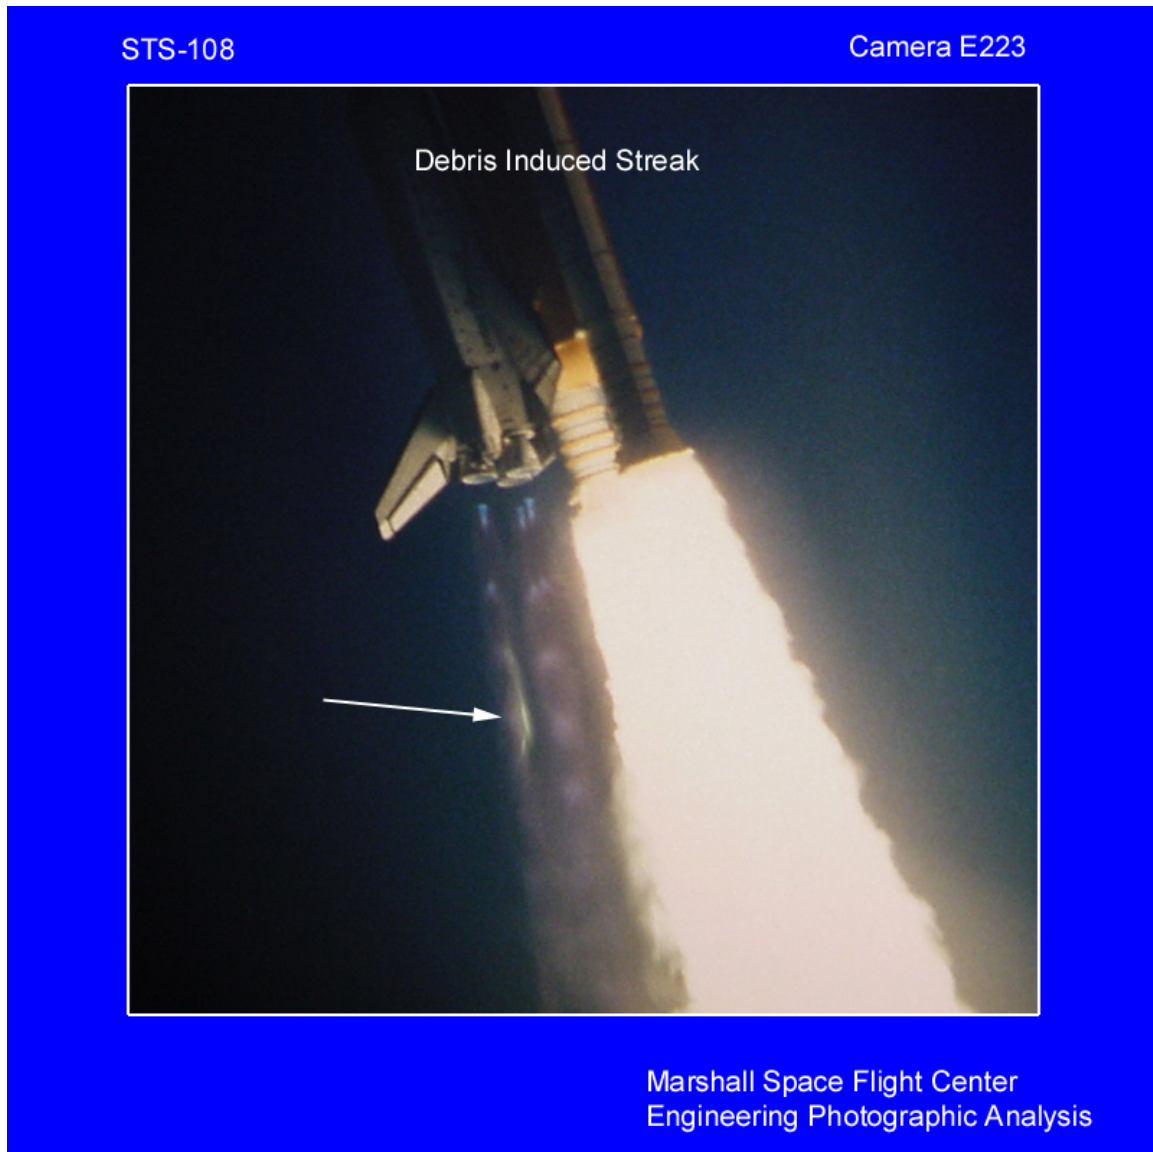
Figure 21. Film Camera E223: Debris Induced Streak

Typical debris induced streaks were noted in the SSME plumes.

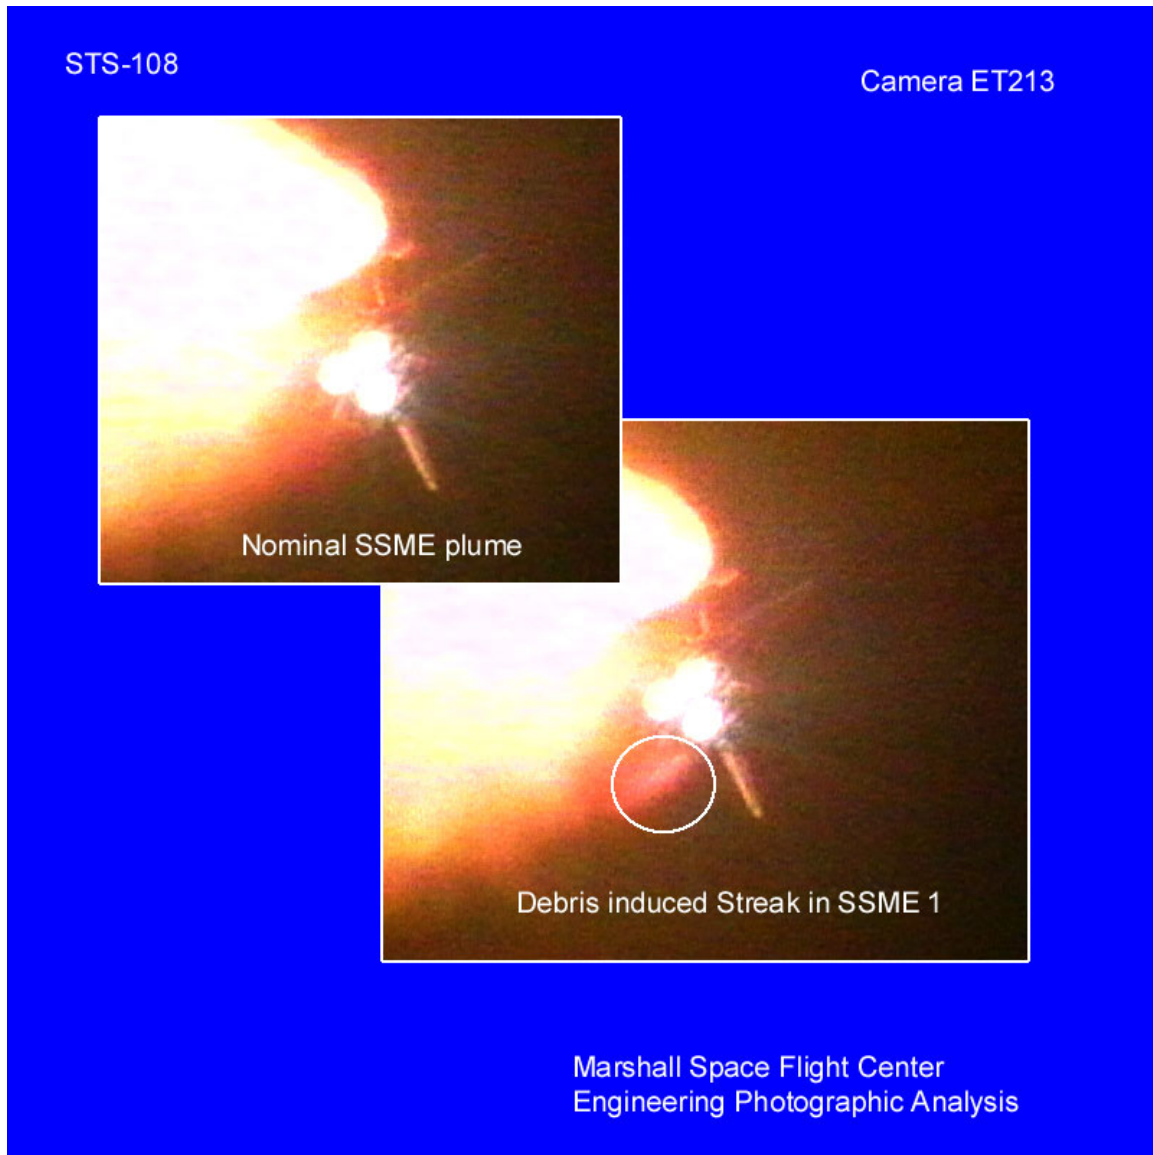
Figure 22. Video Camera ET213: Debris Induced Streak in SSME Plume

Debris induced streaks were noted in SSME plumes.

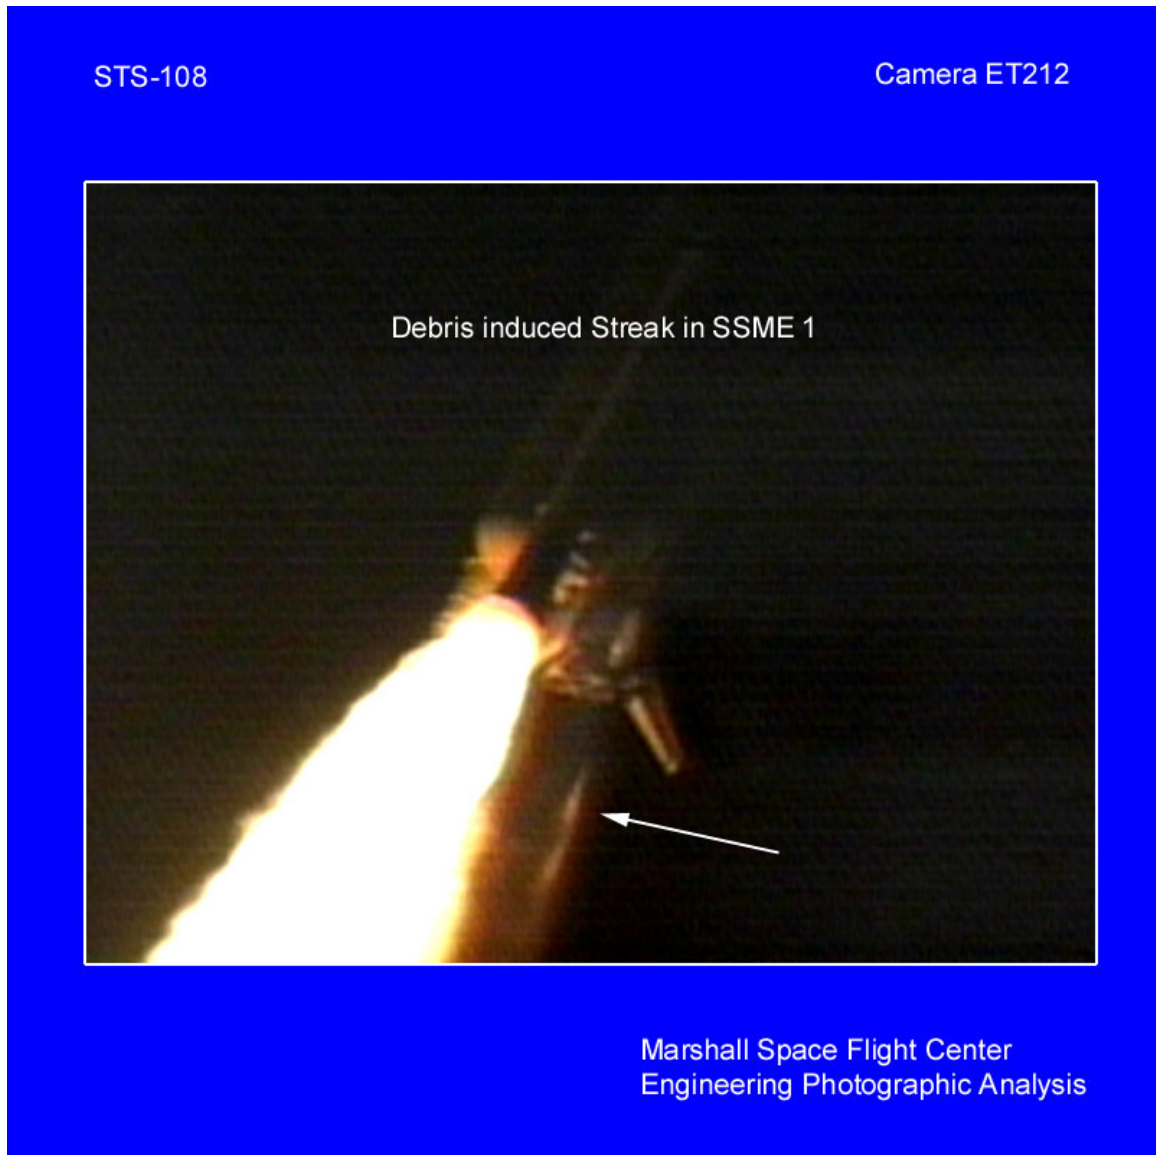
Figure 23. Video Camera ET212: Debris Induced Streak in SSME Plumes

Debris induced streaks were observed in the SSME #1 plume.

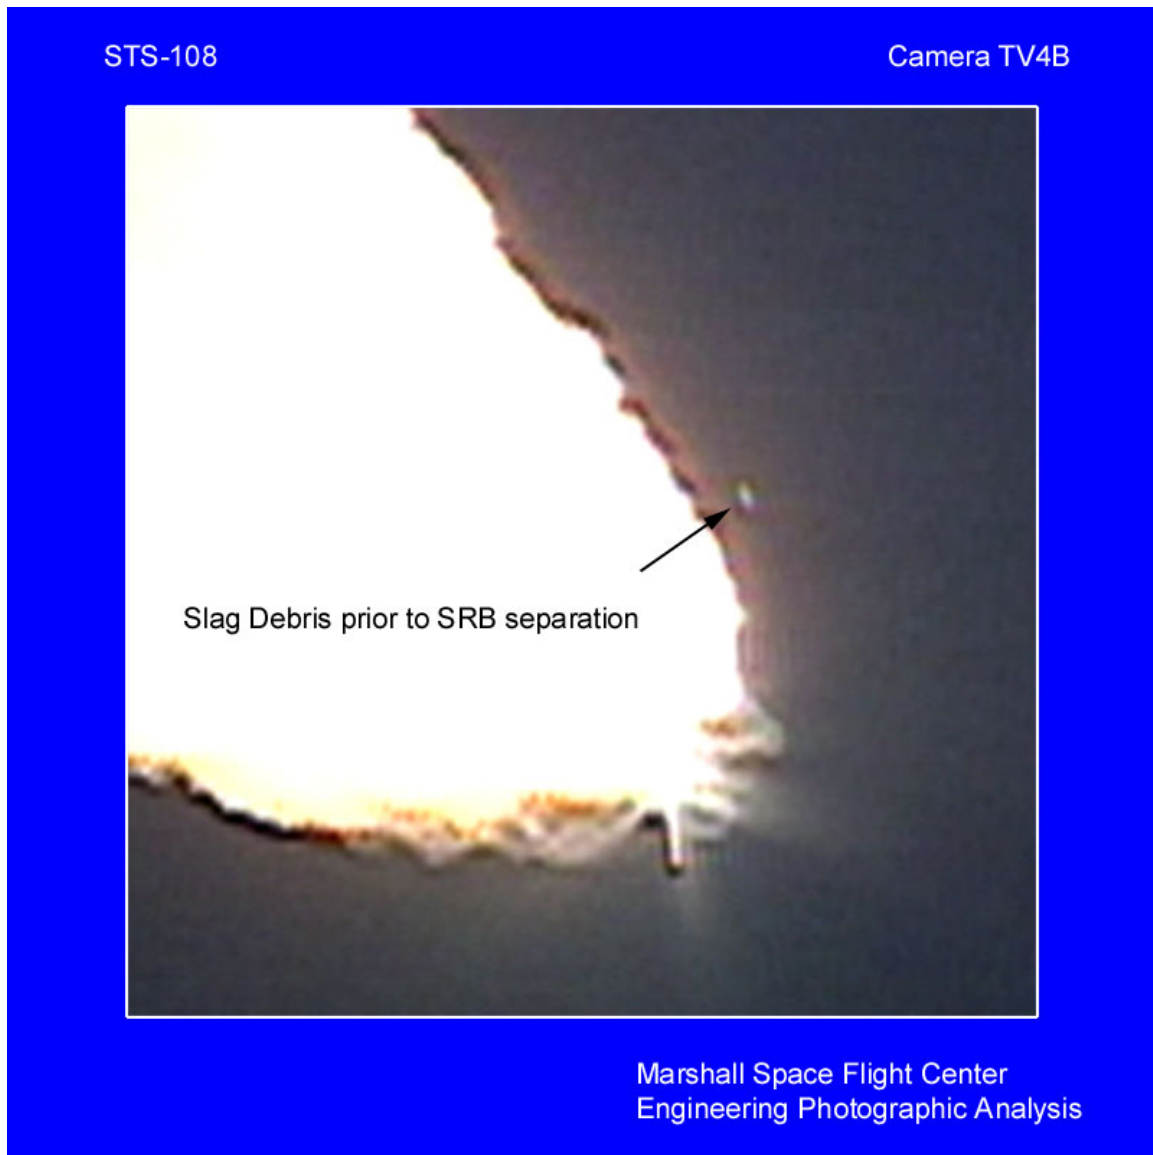
Figure 24. Video Camera TV4B: Debris Ejected from SRB Plumes

Debris was observed emanating from the SRB plumes prior to SRB separation.

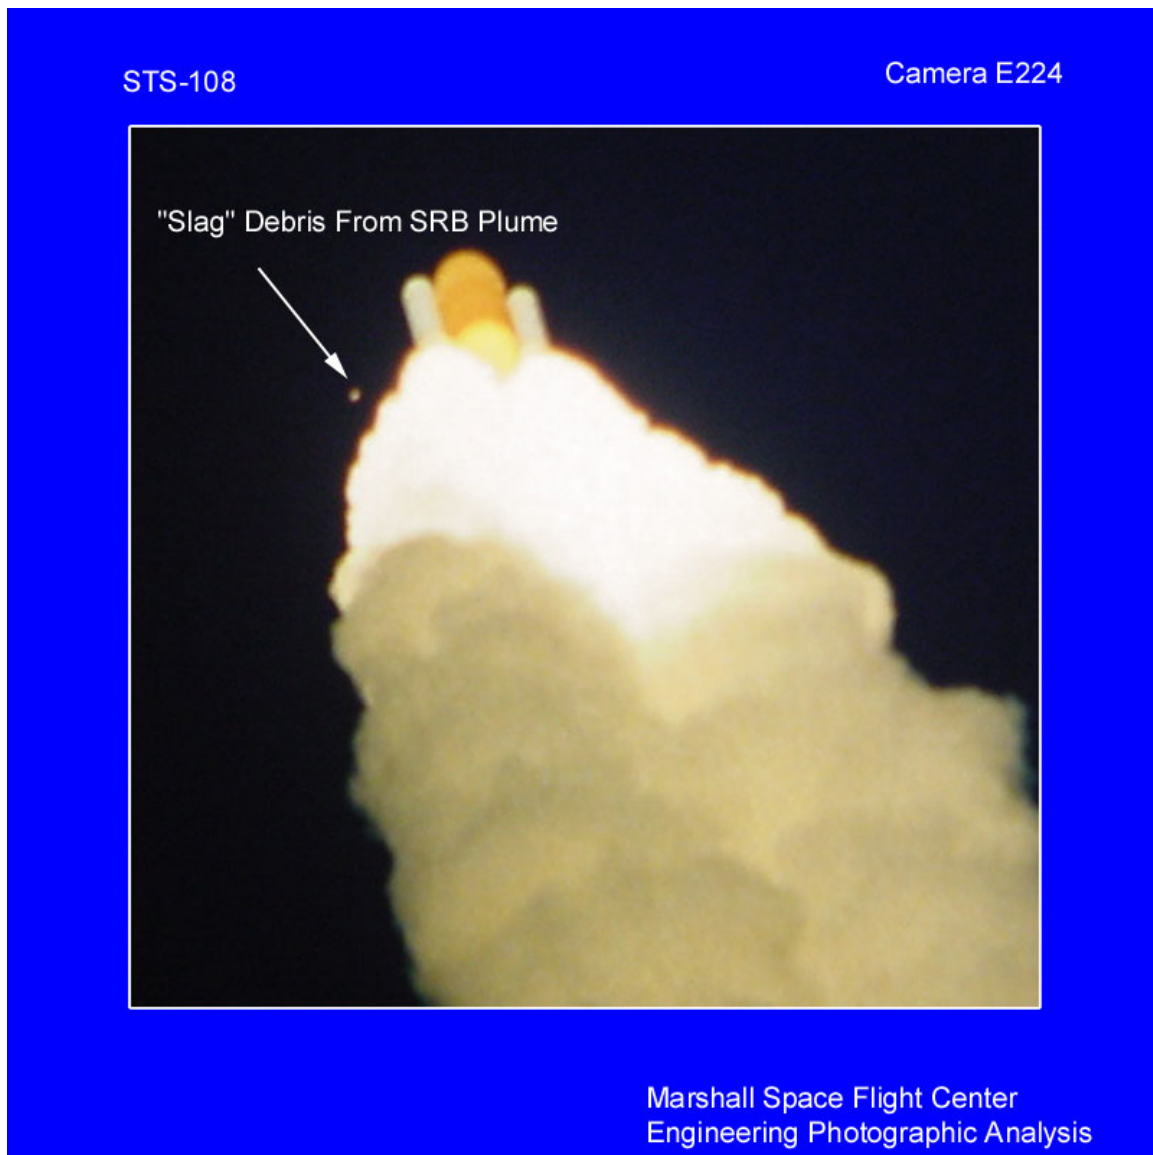
Figure 25. Film Camera 224: Debris Ejected from SRB Plumes

Slag ejected from the SRB plumes was observed.

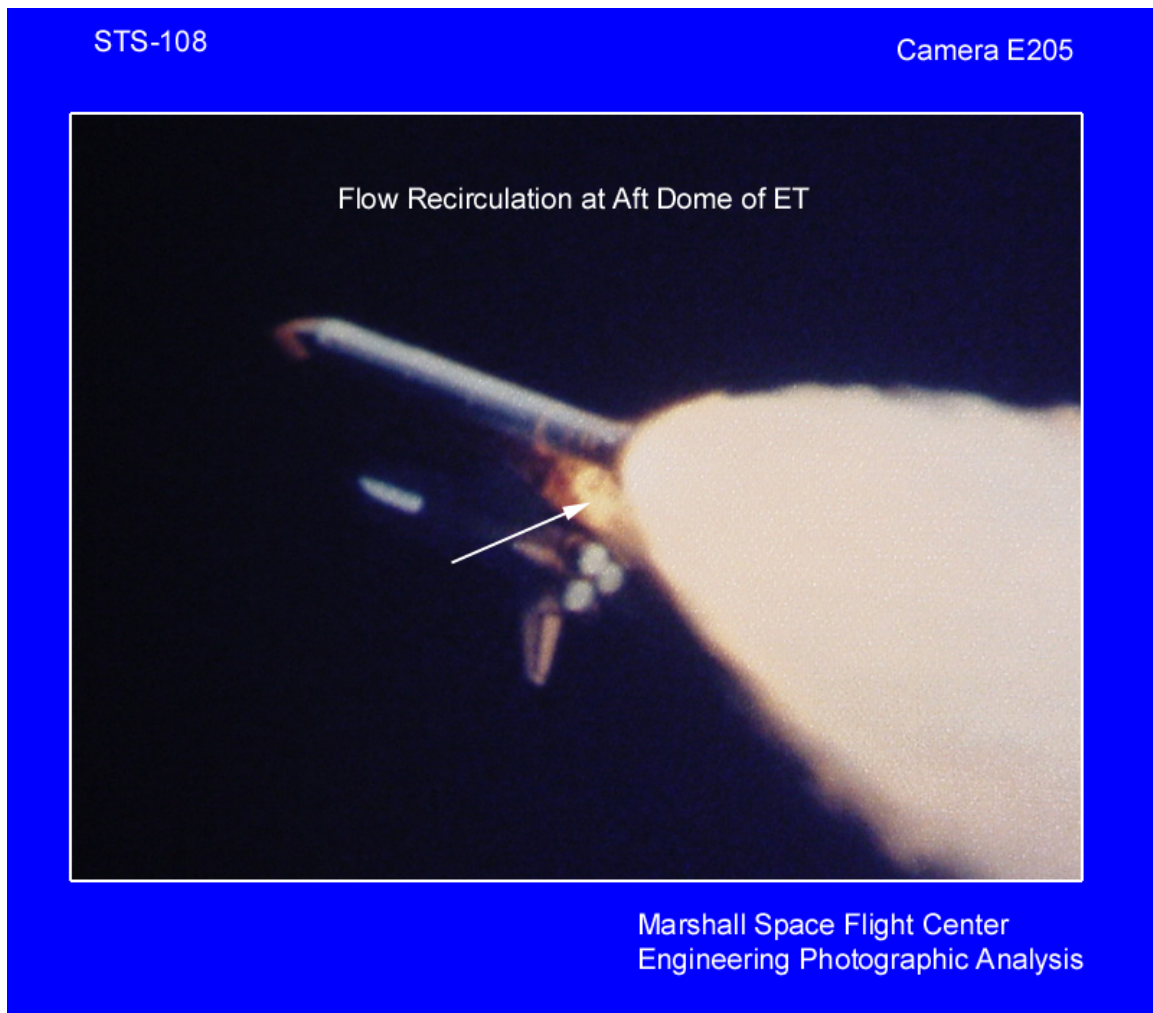
Figure 26. Film Camera E205: Flow Recirculation

Flow recirculation was noted at the aft of the external tank.

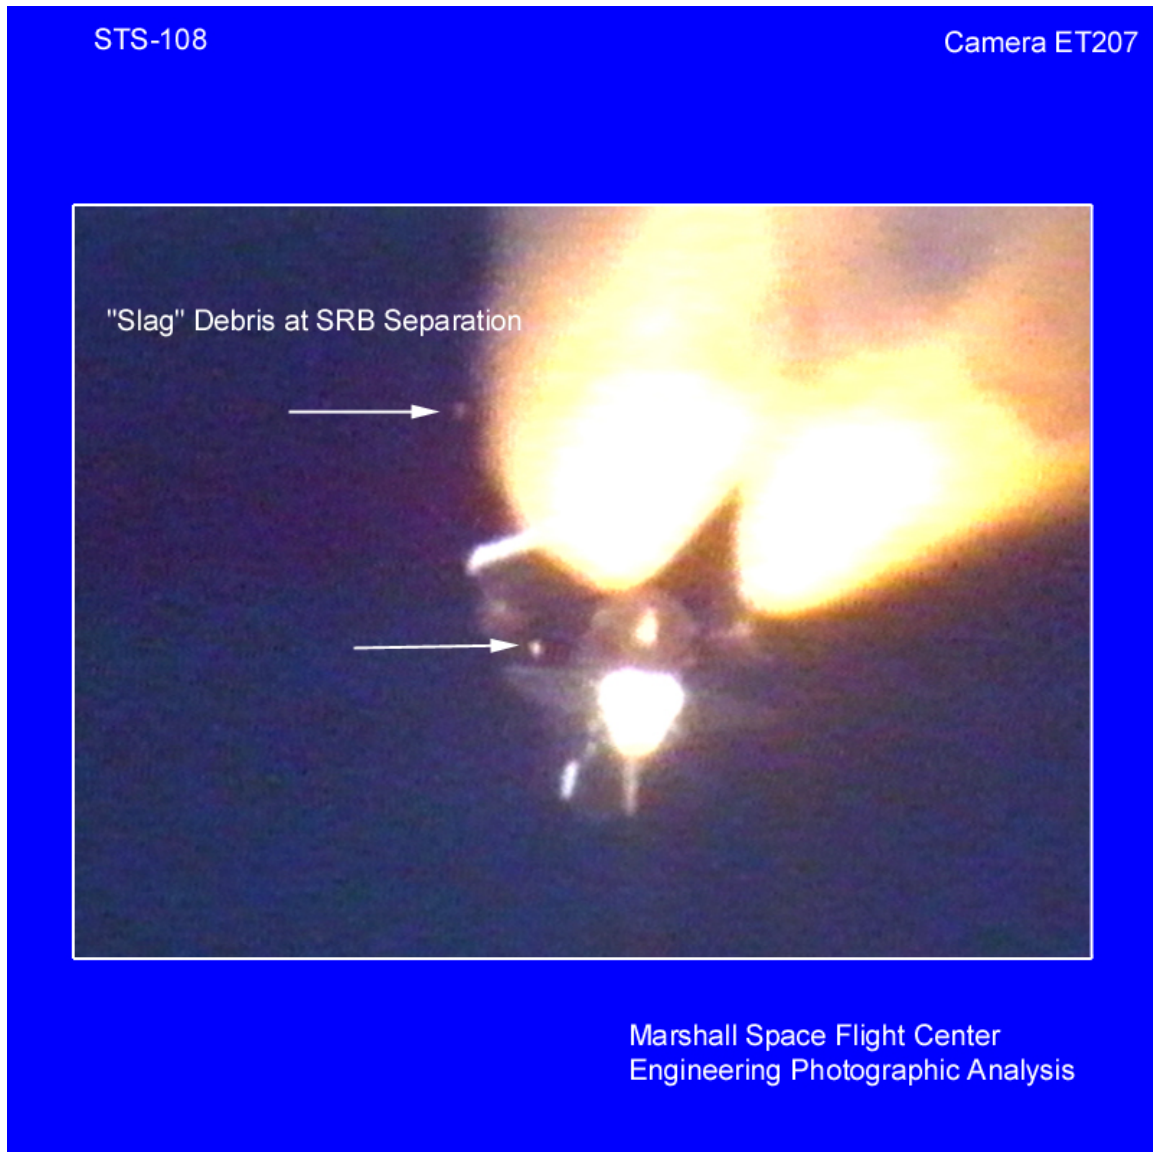
Figure 27. Film Camera E207: Debris at SRB Separation

Slag debris was observed emanating from the SRB plumes at SRB separation.

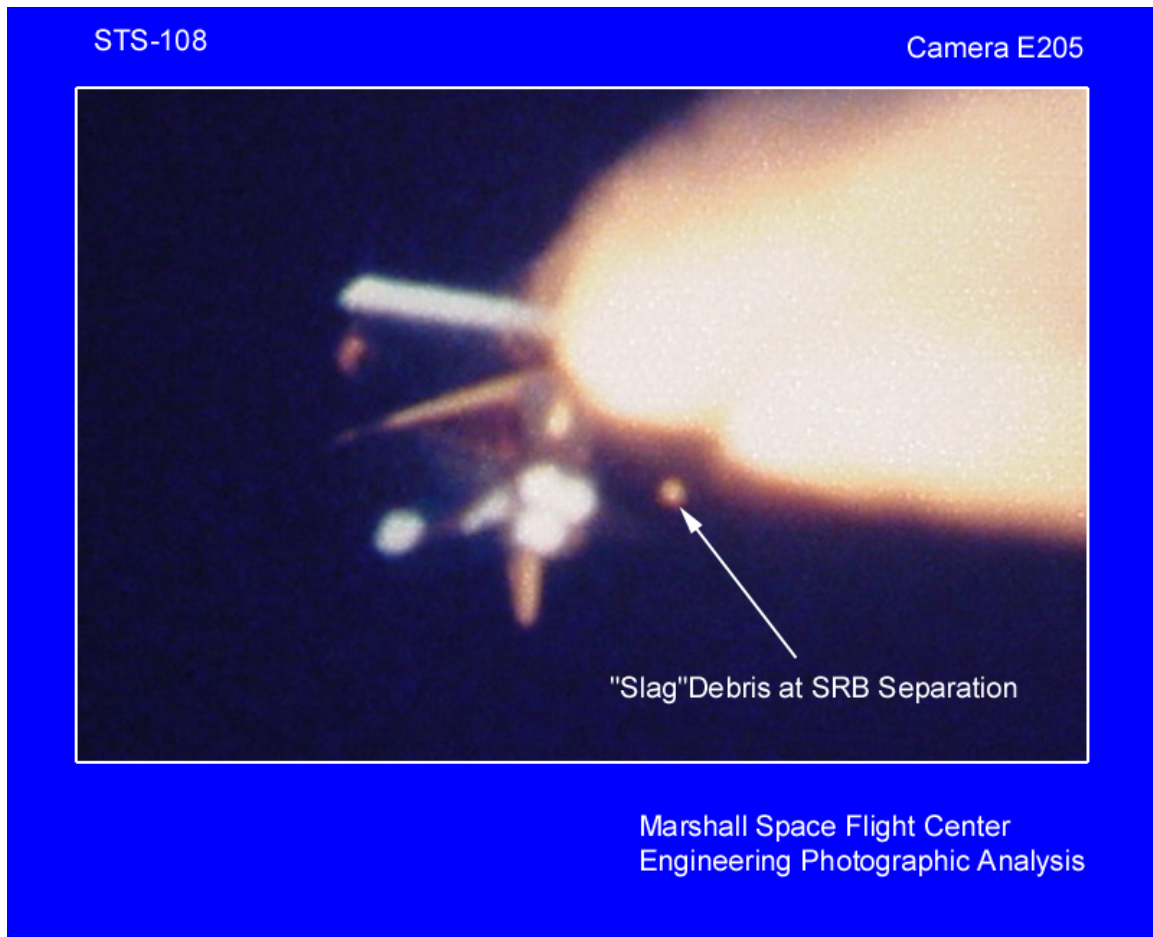
Figure 28. Film Camera E205: Slag debris at SRB Separation

Slag debris from SRB plumes was observed at SRB separation.

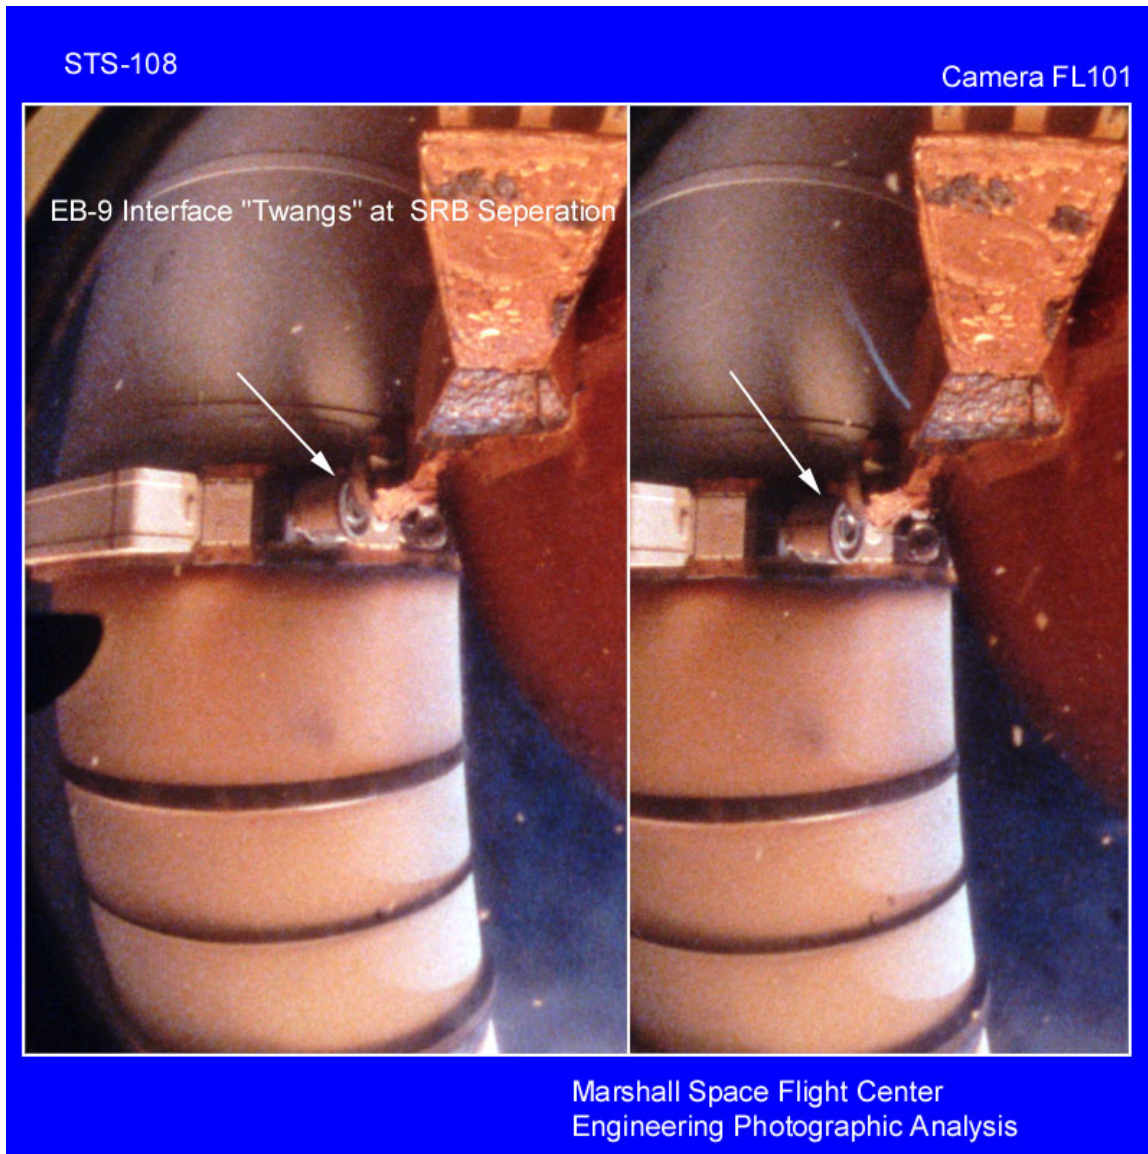
Figure 29. Film Camera FL101: ET/SRB Separation

A slight twang at the EB-9 electrical connector interface of the ET/SRB upper attach was observed at ET/SRB separation. This motion has been observed on previous missions.
